SUBJECT: A Floorhand Dies When He Falls Off a Mobile Oil Well Servicing Rig

SUMMARY
California FACE Report #14CA001

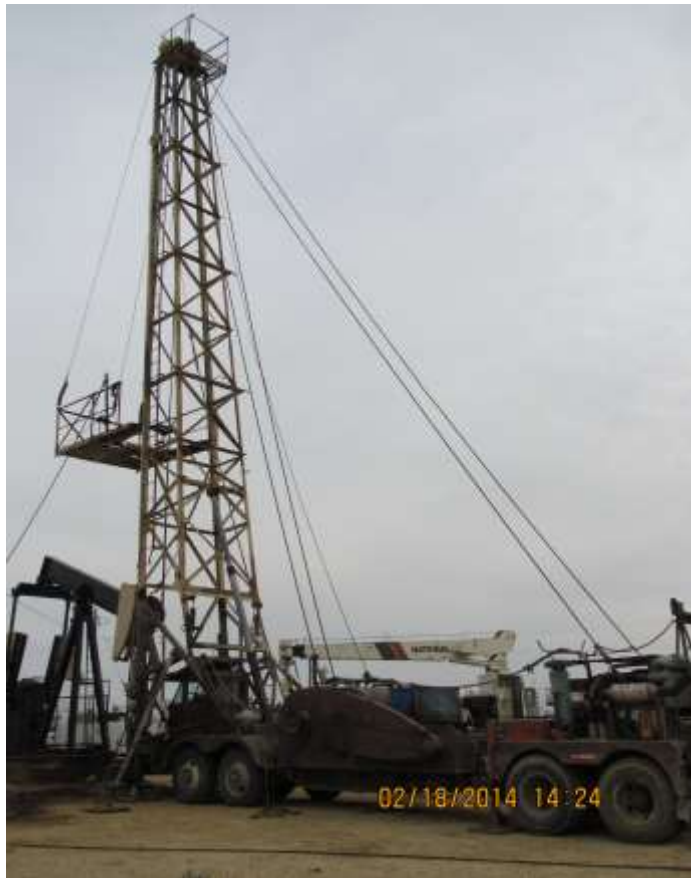
Exhibit 3. The rig at the incident scene with the boom extended.

Location where the victim
was working prior to his fall

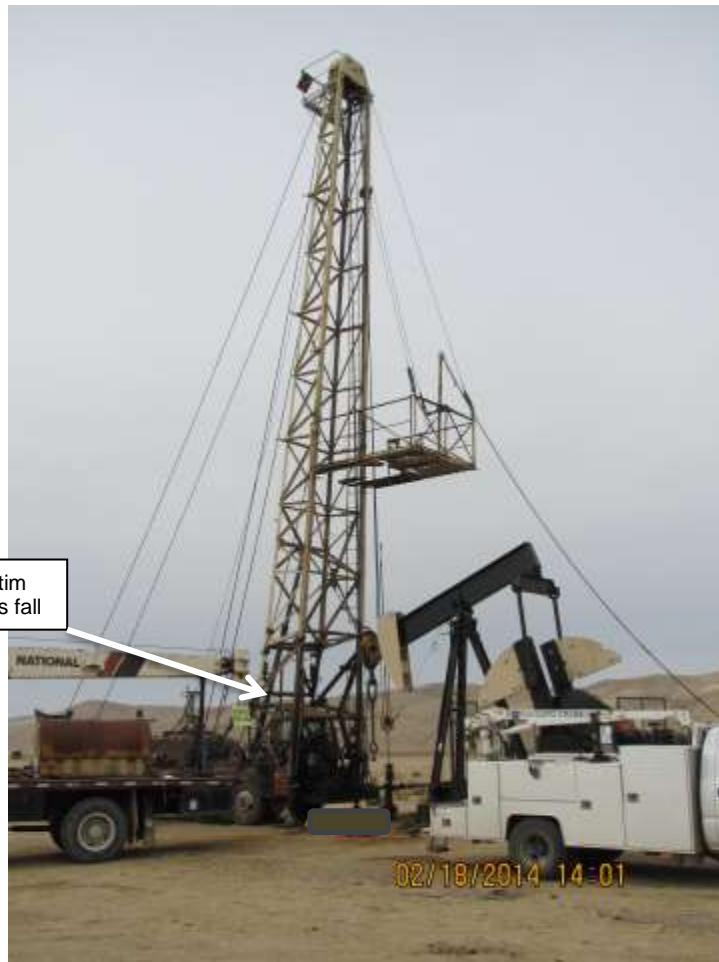
Discussion: In this incident, the victim was standing on the deck of the cab, approximately eight feet above ground level, and did not attach his personal fall restraint system. A fall from more than six feet can result in severe injury including fracture, internal bleeding, and possible death from spinal injury. The California Petroleum Safety Orders require that a safety belt and lanyard be used as a restraining system for each employee working on a derrick or mast at a height more than ten feet (10') above the derrick, mast floor, or ground level. Federal OSHA requires fall protection for any height greater than six feet for most industries. Severe injury can occur if an employee falls from a height of greater than six feet. This system consists of anchorages, connectors, and a body belt or full body harness. Had the victim in this incident attached his personal fall restraint system to an anchor point, the fall may have been prevented.

Discussion: In this incident, the victim was standing on a deck without guardrails, as this would interfere with the boom position during travel. As an older piece of equipment, the deck of this rig was not designed with tie-off points or anchors that allowed for a fall restraint system. Some newer mobile oil well servicing rigs are designed with features that can be used for this purpose. Alternatively, the deck could be retrofitted with anchor points. Although the victim and likely many other employees had worked off this deck many times in the past without incident, the risk of severe injury from a fall was nonetheless present. Had the employer ensured that this mobile rig had anchors for a fall restraint system, the victim may have tied off and prevented his fall.

Exhibit 4. The location where the victim fell from.

Recommendation #1: Employees utilize a personal fall restraint system when working six feet above a work floor, ground, or other working surface.

Recommendation #2: Mobile oil well servicing rigs are equipped with fall restraint tie-off points at employee working positions.
